Genesis Models ED1 & ED2

CASE STUDY

MODEL ED1 INSTALLED ON DESALTER AT REFINERY

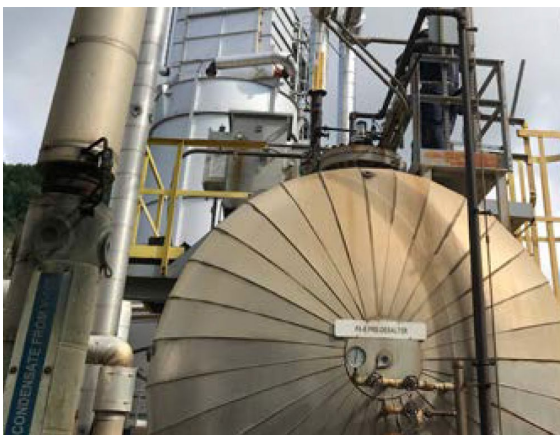
Model ED1-210B-310 Multiphase Detector with PEF-5400-A00-01-106 Pentarod probe

A Genesis™ Multiphase Detector with a 106-inch long Pentarod probe was installed on a 13-foot diameter desalter at a refinery in the Eastern United States for monitoring and comparison vs. an existing Fisher torque tube displacer transmitter. Desalters are an important process element at refineries as desalting removes both salt and residual free water. The goal in this application is to keep the interface level constant for optimum efficiency. The challenge is that interface level must be accurate enough to control and keep free water from contacting the desalter electrodes, which can cause expensive damage.

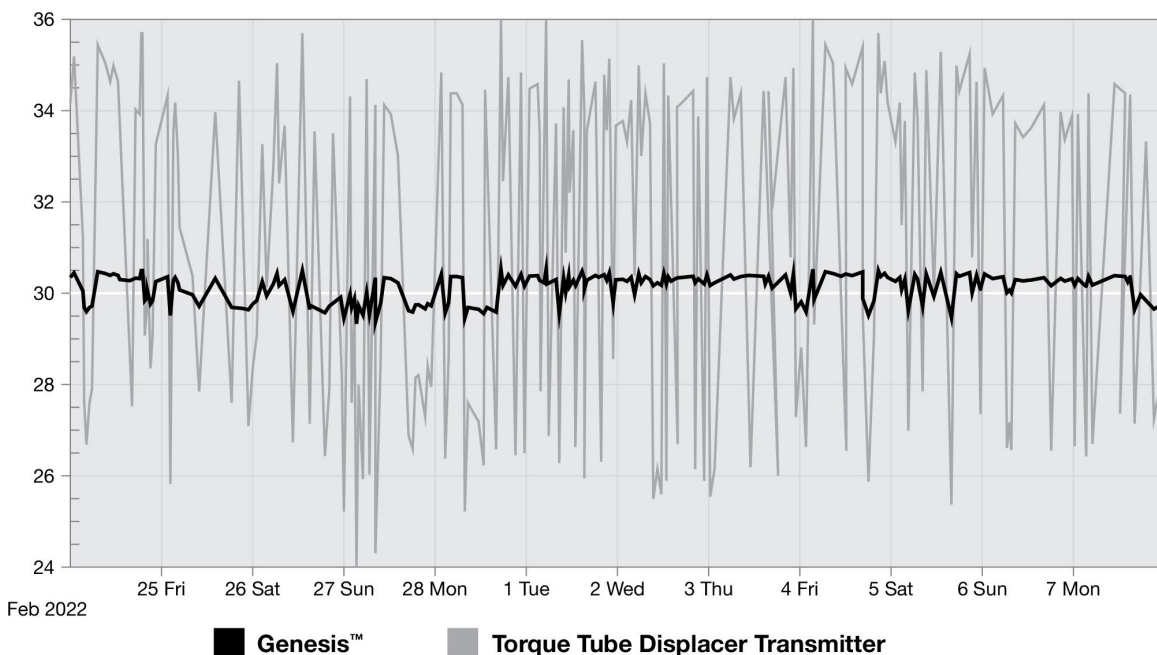
This study presents the immediate results, but over time, an even greater return may be seen in terms of reduced corrosion and fouling in downstream piping/equipment due to tighter control of the emulsion. In addition, level control accuracy was improved from $\pm 15\text{--}20\%$ around the setpoint with the displacer down to $\pm 1\text{--}2\%$ with Genesis. The operator has benefited by this improved control in both time (with respect to maintenance) and money savings (with respect to chemical additives). The next step is to install a longer probe in place of the torque tube. A longer probe resting closer to the bottom of the vessel will allow earlier sand detection. Knowing the level of the sand will allow the operator to properly plan shutdowns, instead of routinely shutting down the vessel every six months for cleaning. It must be noted that not all desalters will have sand accumulation; however, many separators will indeed have sediment/sand and this device will provide enhanced visibility to all levels. The goal from the onset was to have Genesis control the levels in the vessel; however, it happened a little quicker than expected. A true success story with this new and exciting product!

Commissioning test results were verified by comparison to visual samples taken from side taps, with initial indications showing a torque tube error of up to 20%. Three weeks later, an upset within the vessel was significant enough to disable the torque transmitter to the point where it would no longer read below 70% level. At one stage during the displacer malfunction, it was proven (by customer via side taps, and later by viewing the %Water Graph on the Model ED1 DTM) that there was actually water ABOVE the oil in the vessel, as described by the customer:
